Manhole Inspection Summary

Manhole # S13EE2012MH

Location Address: **2114 WESTERN RUN DR**

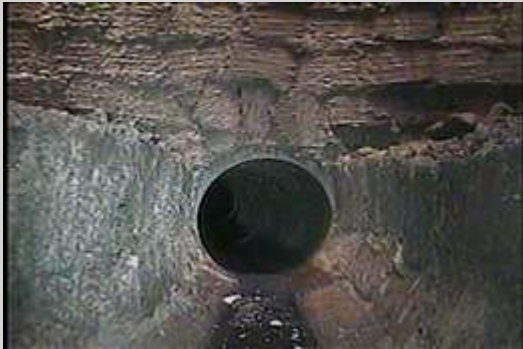
8 in. Circular Gravity Sewer Pipe Out @ 12 O'Clock

Pipe Material: **Clay** ☐ Pipe Lined

Invert Depth: **7.65** (ft.) Flow Characteristics: **None**

Infiltration: **None** Pipe Seal Cond: **Unknown**

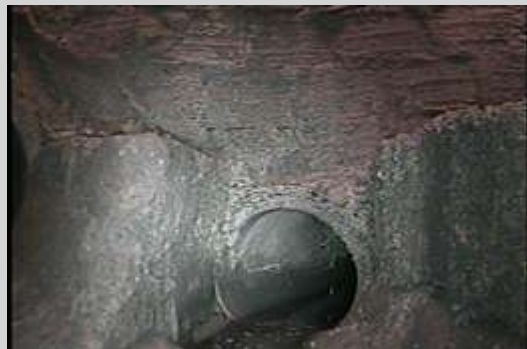
6 in. Circular Gravity Sewer

Pipe Material: **Clay**

Infiltration: **None**
